Summary of OmegaPost NTPEP Test Results.

TECHNICAL MEMORANDUM

Contract No.: 1903665
Test Report No.: 613301-01-2
Project Name: Impact Recovery Systems, Inc. OmegaPost™ 2 High Performance Delineator – TTCD-2019-01-001 – High Speed Applications
Sponsor: AASHTO National Transportation Product Evaluation Program (NTPEP)
DATE: 2019-09-30

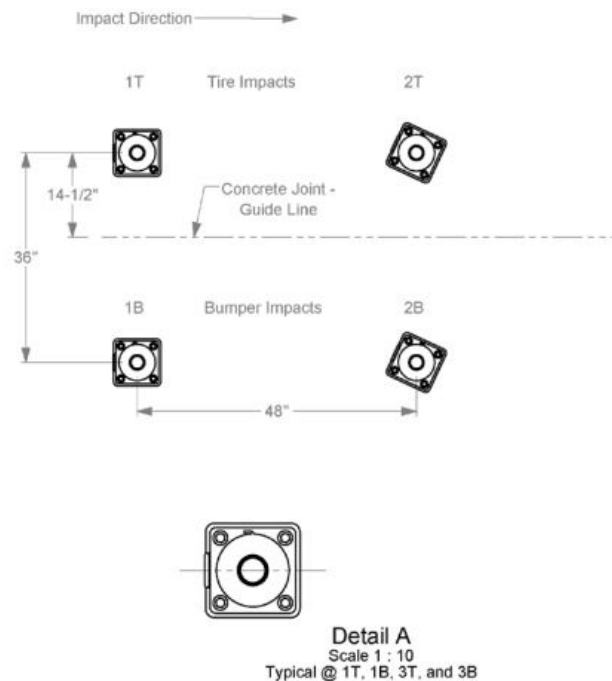
1a. Secure Delineators 1T, 1B, 2T, and 2B on concrete surface with E-bond epoxy according to manufacturer's instructions. Secure Delineators 3T, 3B, 4T, and 4B on asphalt with Plastic Inserts, grade 8 Flat Washers, and 1/2" x 4" Lag Screws according to manufacturer's instructions. Orient delineators as indicated in Detail Views.
